Coad Bog, Co. Kerry Conservation Management Plan 2017-2023

Coad Bog, Co. Kerry, Conservation Management Plan 2017-2023

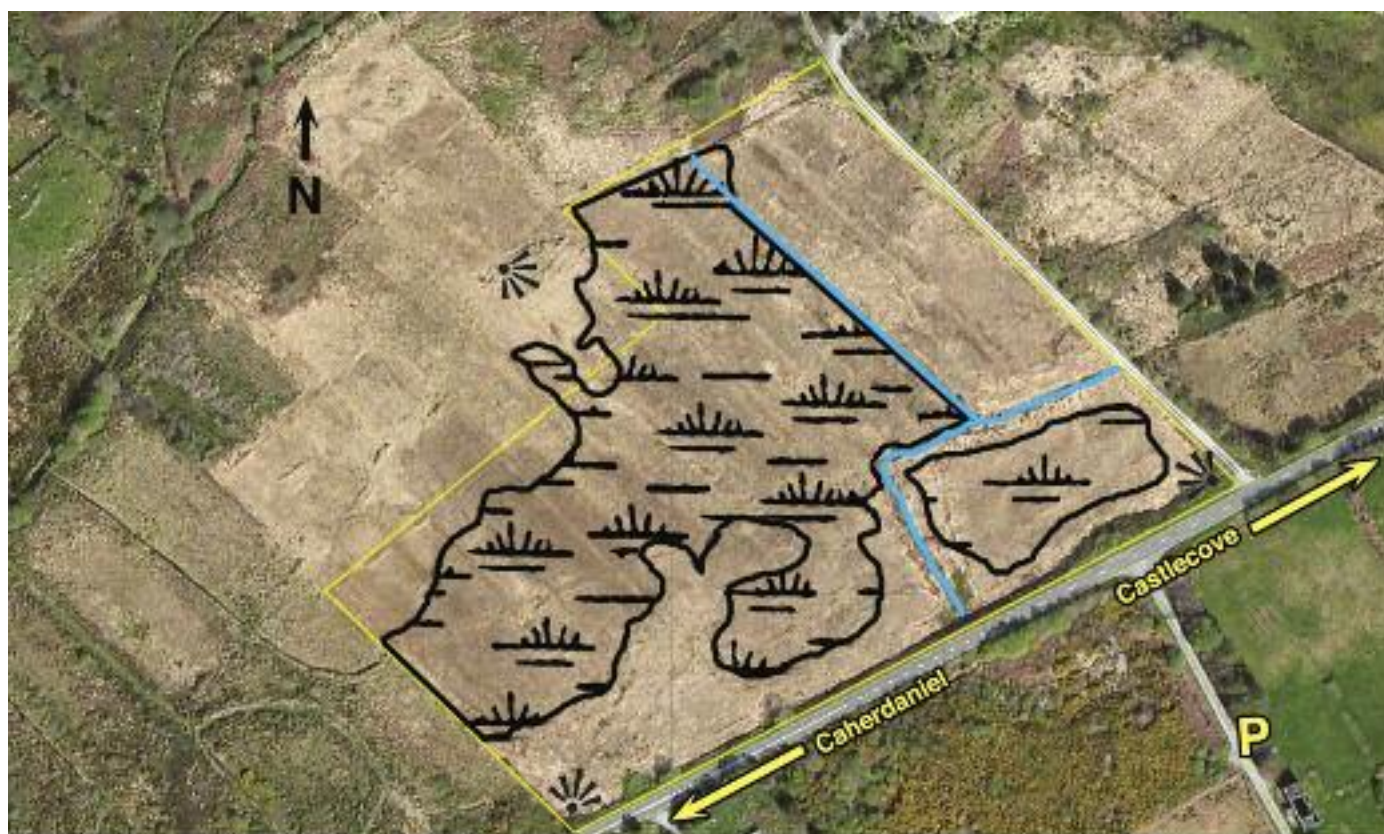
Figure 4: Close up aerial view of Coad detailing the extent of the wet bog habitat present on the site which includes 1.5ha of active blanket bog habitat, the site boundary, a ditch or stream and the location of towns and viewing points, modified from Bing Maps

Endangered Habitats Present: There is 1.5ha of the Annex I habitat Active Blanket Bog 7130 as defined by the Habitats Directive 92/43/EEC currently present on the site with the potential to extend this area to 3ha with the right management (see Figures 4 and 5).

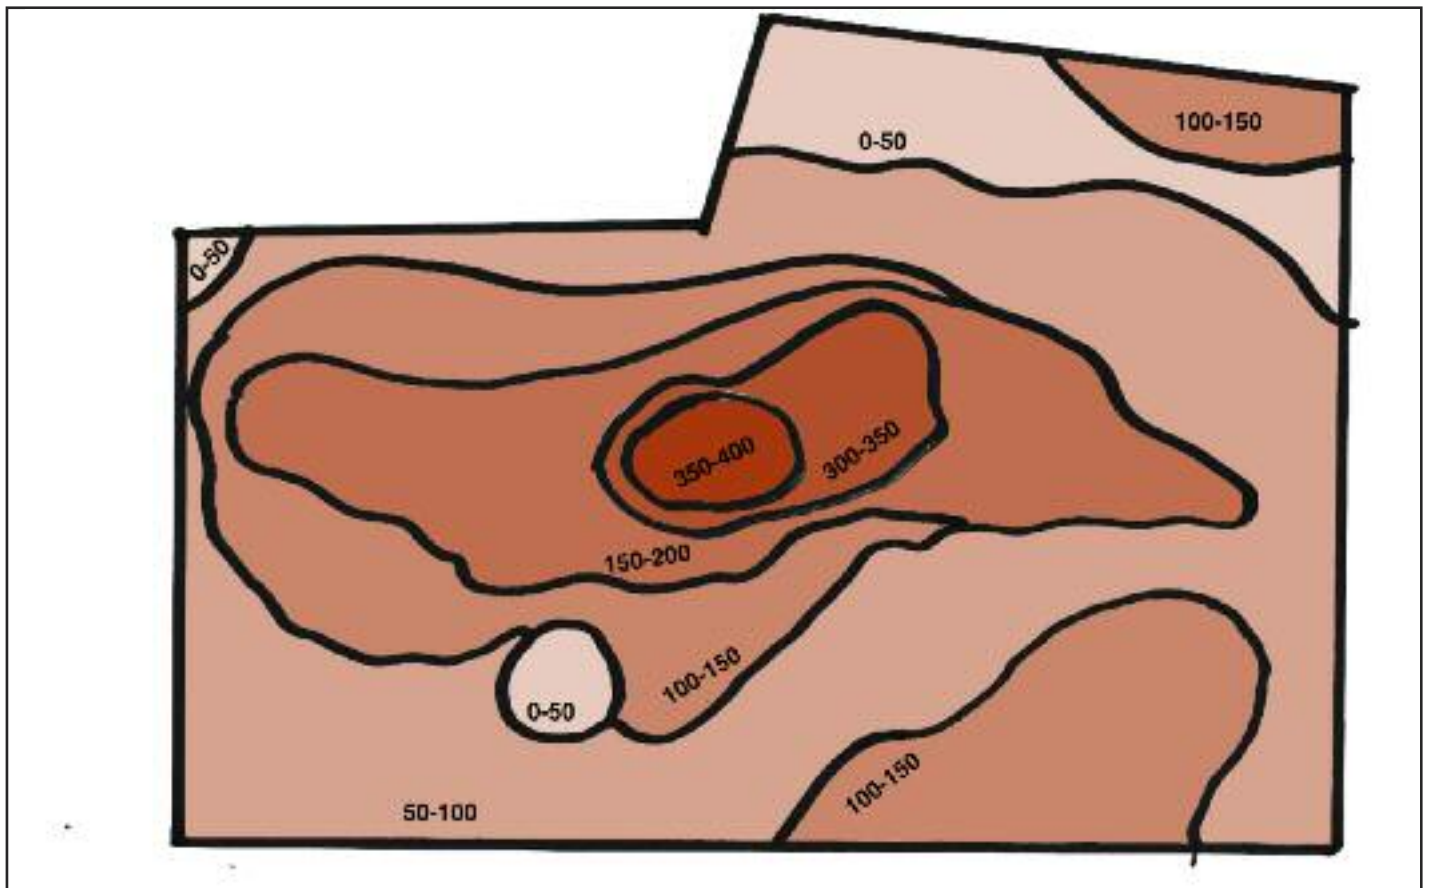
Figure 9: Peat Depth map for Coad Bog showing depths across the site in 50cm increments

The deepest measurement found at each point was used to diagnose peat depth (Figure 9). Depths ranged from 33cm to 373cm across the site. At each point GPS readings were also taken to provide a topography map of the site. These data were then used to map the overall topography of the site

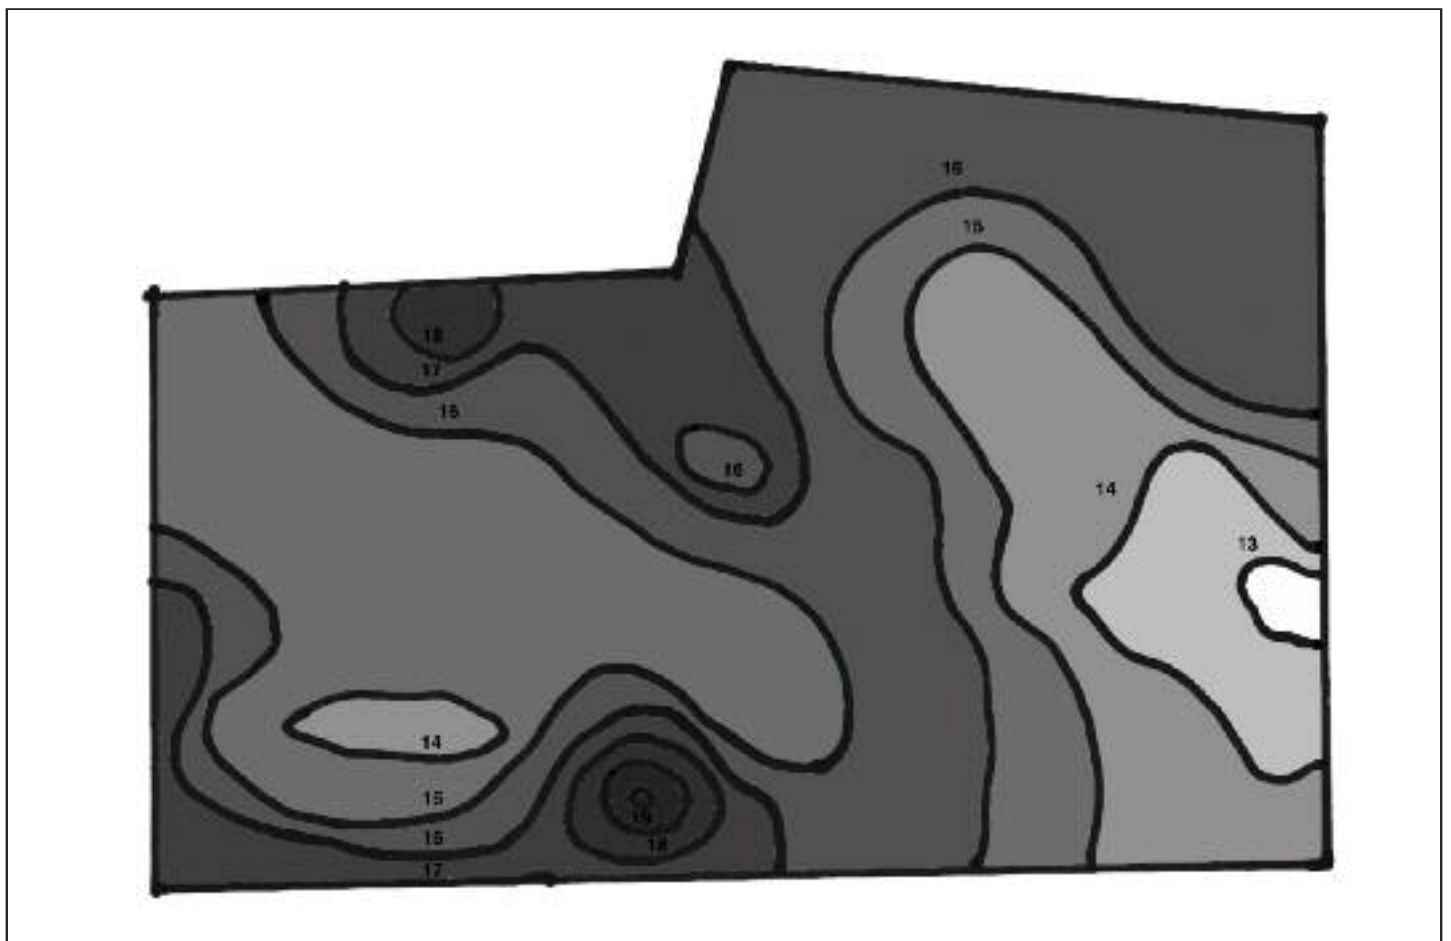
Figure 10: Topography map for Coad Bog showing height above sea-level in metres across the site

Coad Bog was found to lie between 13 and 20m above sea level with significant variation across the site (see Figure 10).

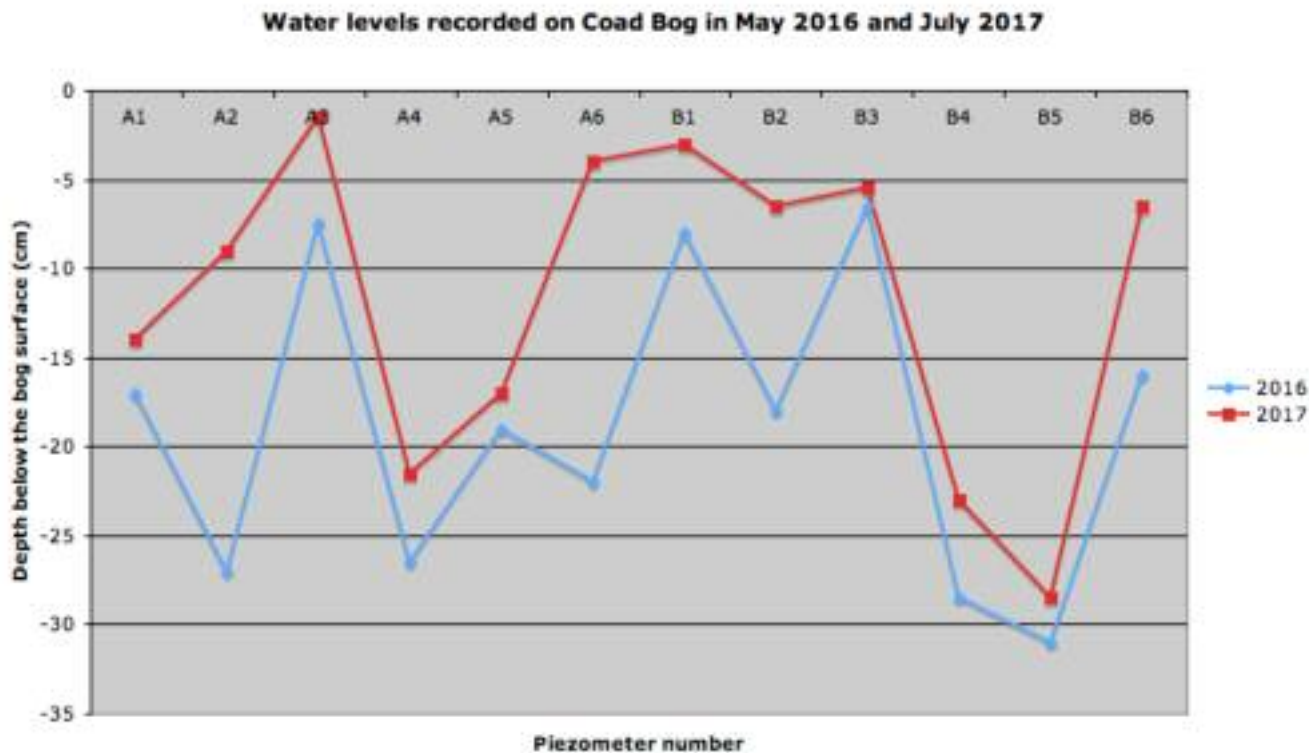
Figure 12: Water table graphs for Coad Bog 2016 and 2017. The water levels in piezometer A6 show dramatic increases. This may be attributed to the way in which the water level in the piezometer is being measured as the piezometer is located in soft Sphagnum peat.

Water measurements were recorded in 2016 and 2017 and the data collected are presented in Appendix IV. A graph of the water table is shown in Figure 12.

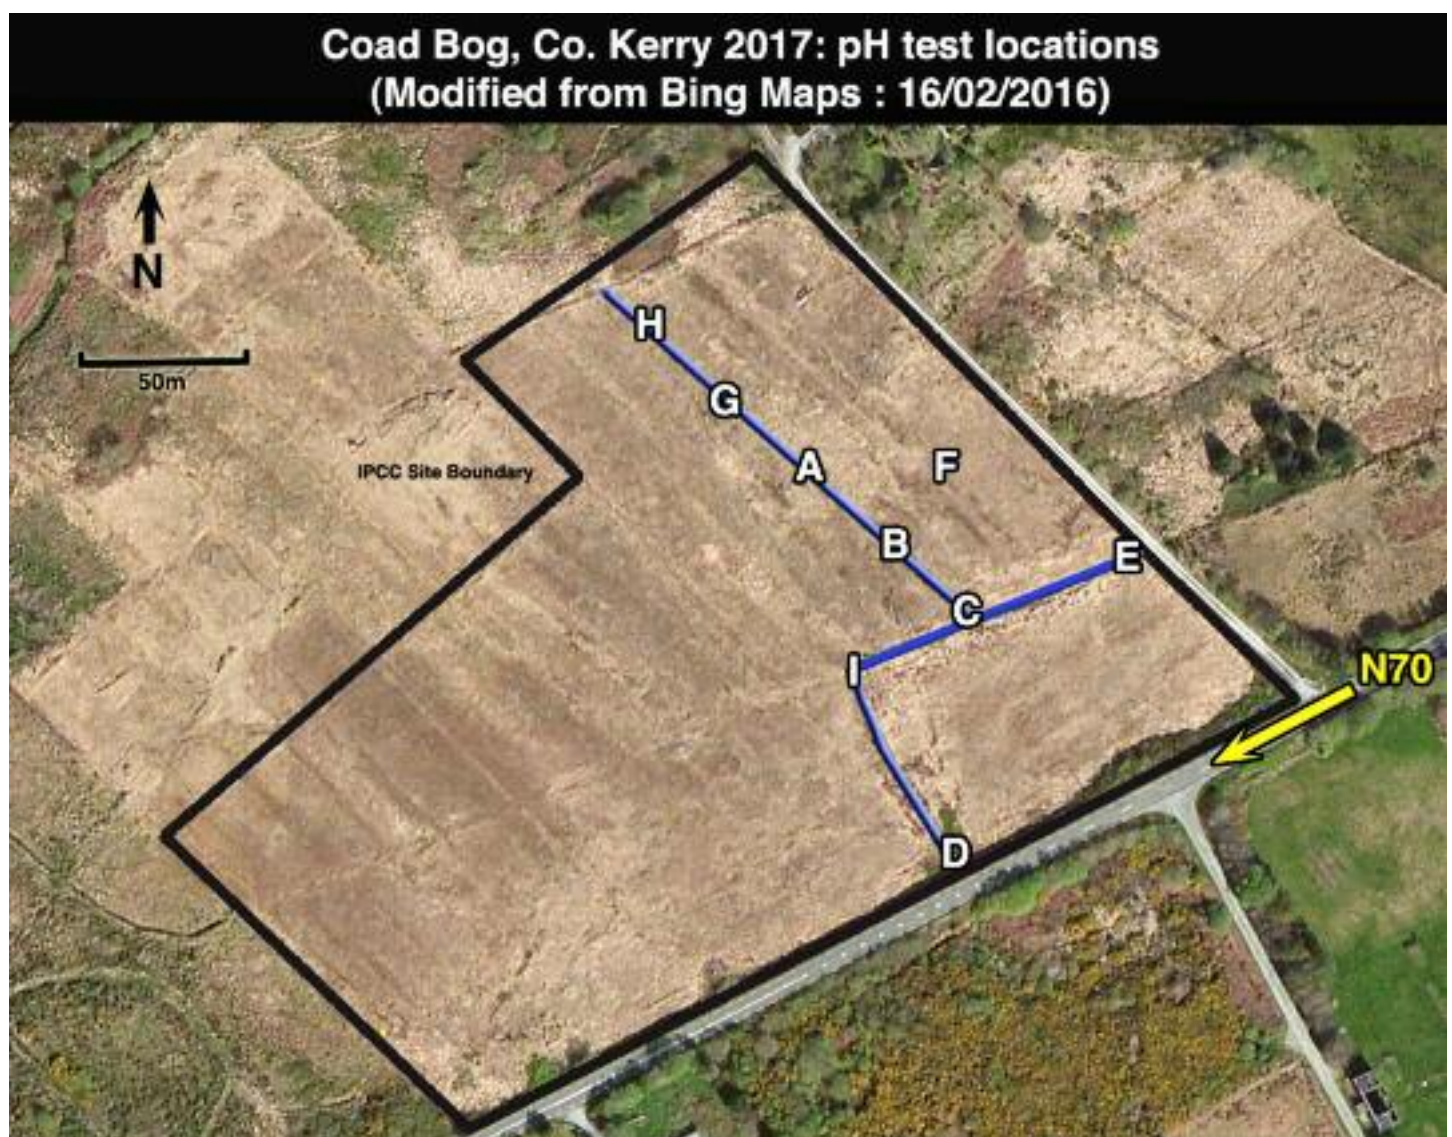
Figure 13: pH measurement locations on Coad Bog 2016 and 2017

pH readings were recorded on the 25th May 2016 from 6 locations on Coad Bog and found to range from 5.17 to 6.69. *how do these compare with other bb and we need more results from 2017.* The locations of the sample sites and the results recorded are shown in Figure 13 and Table 10 respectively.

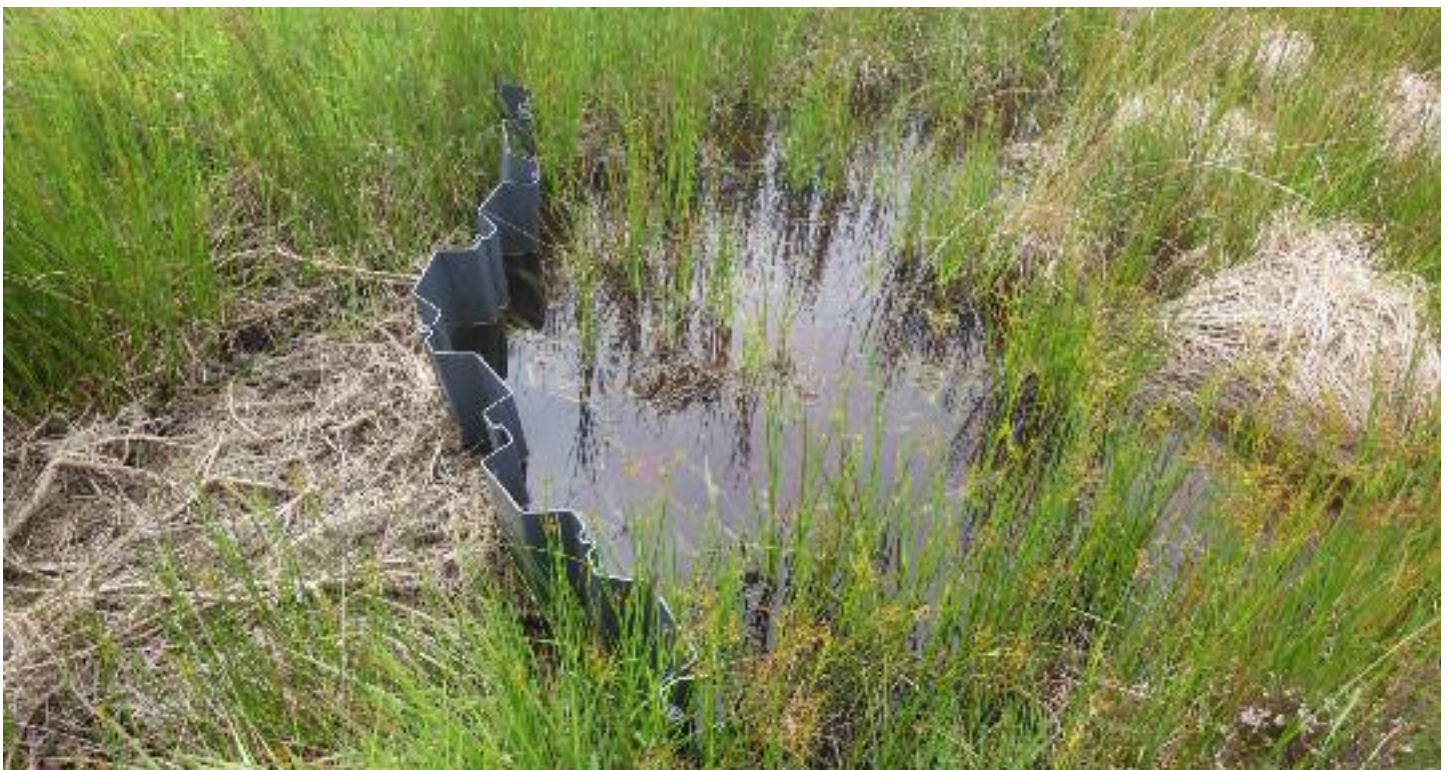
Figure 16: Photo taken in July 2017 showing water being held back by dam inserted in drain A in May 2016.
Photo: K. Geraghty

Figure 16 shows a dam holding water on Drain A on Coad Bog in 2017.

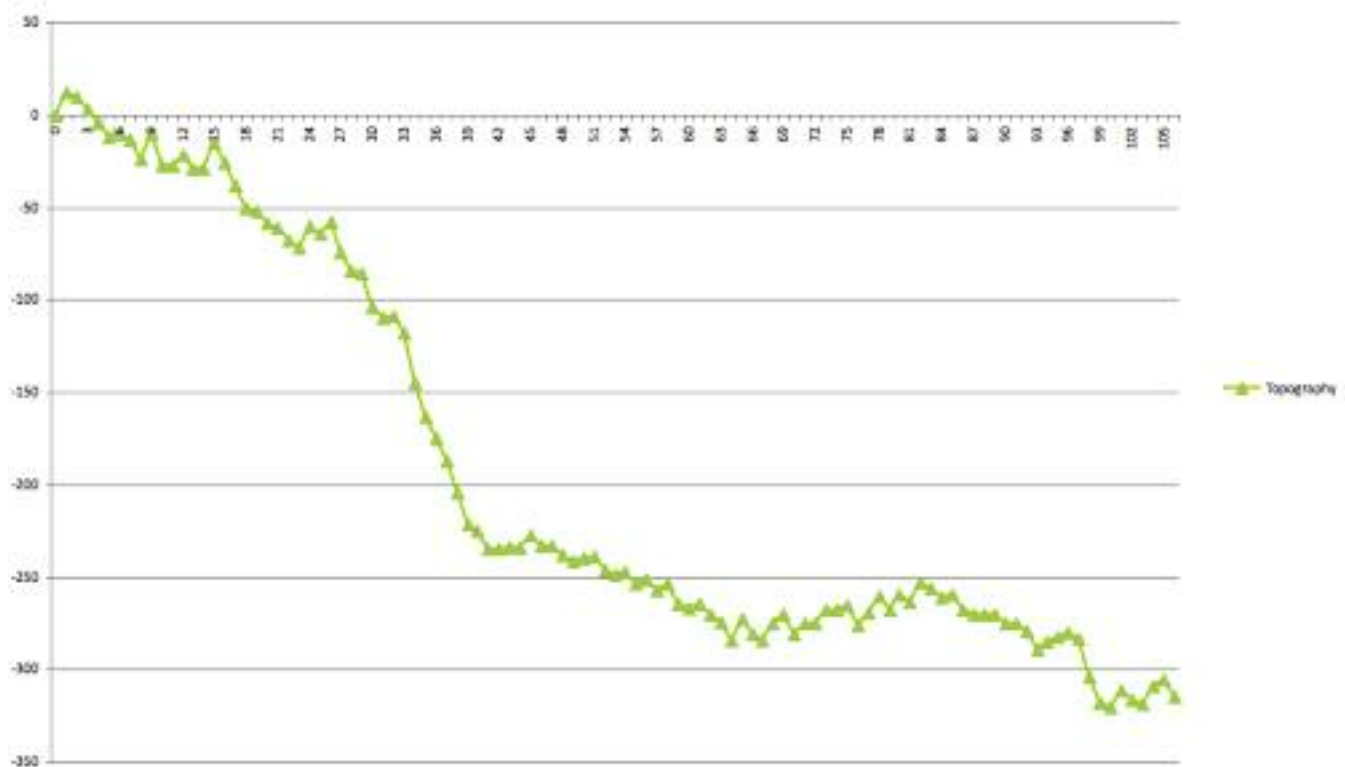
Coad Bog, Co. Kerry: Profile of Drain B (West to East)

Figure 17: Profile diagram for Drain B on Coad Bog 2016.

The profile diagram for Drain B is shown in Figure 17 and dam construction is required on this drain.
