# Sphagnum Cultivation as a means of Restoring Irish Raised Bog Habitat

Tadhg Ó Corcora, Irish Peatland Conservation Council

*Sphagnum* Cultivation as a means of Restoring Irish Raised Bog Habitat. Poster paper presented at 'Peatlands a New Conversation' conference hosted by the Irish Peat Society 2015.  
© 2015 Tadhg Ó Corcora MSc, Conservation Officer, Irish Peatland Conservation Council, Lullymore, Rathangan, Co. Kildare R51 V293, Ireland, Email: bogs@ipcc.ie, www.ipcc.ie

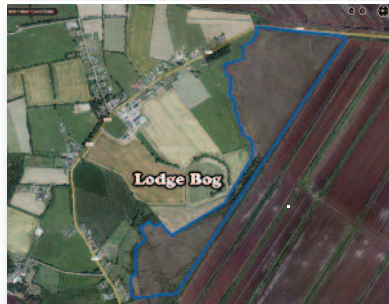
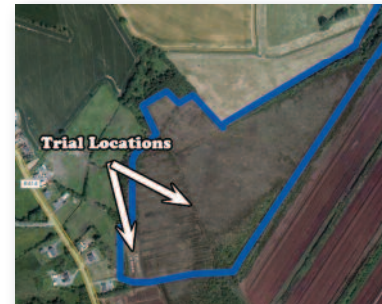
Lodge Bog has two distinct lobes and is surrounded by cutaway bog habitat and the mineral island of Lullymore. Significant drainage occurred historically on site while the target *Sphagnum* transfer area was once used as a spreading ground for domestic turf cutting

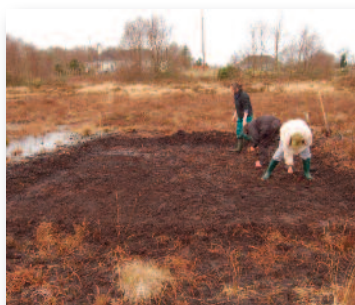
**IPCC volunteers prepare one of the *Sphagnum* transfer sites on Lodge Bog South West**

This was the first time that the *Sphagnum* transfer technique was trialled in Ireland. Sixteen plots measuring approximately 25m<sup>2</sup> were constructed on bare peat (pH 4 – 5) from 2009 to 2013. Fifteen plots were established on a spreading ground where turf had been dried in the past. The *Sphagnum* layer had died and vegetation consisted of *Calluna vulgaris*, *Molinia caerulea*, *Betula pubescens*, *Campylopus introflexus* and *Eriophorum vaginatum*. The 16th plot was established in a borrow pit on the high bog from which peat was used to create a dam in an adjacent drain. Here peat was removed to the level of the surrounding water table. This had been monitored over the previous 6 months.

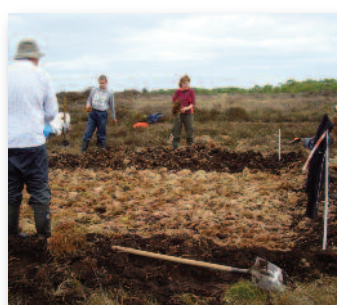
***Sphagnum* is spread across the bare peat at a ratio of 1/10 with the *Sphagnum* taken from the donor site**

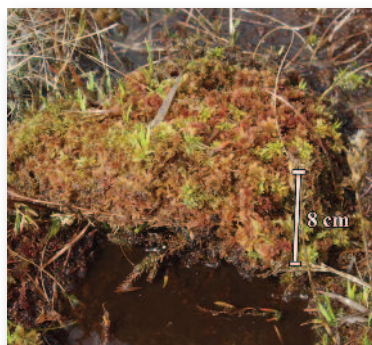
**A significant *Sphagnum* layer can be seen today on the plots established in 2008**

- 50% were successful with good *Sphagnum* regeneration (>30% plot cover)
- 25% failed due to flooding
- 25% showed partial growth of *Sphagnum* (10-30% plot cover)
- The borrow pit trial showed the 3rd highest % cover despite being installed in 2012

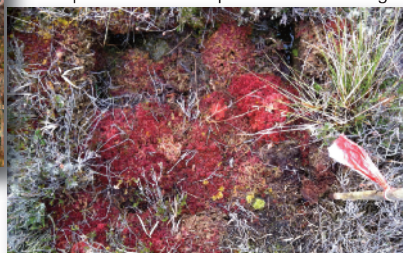
**Proper site selection can lead to significant *Sphagnum* recovery on donor sites (above 2 years after removal)**

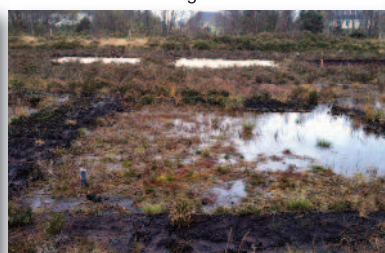
**Hydrological monitoring is essential prior to *Sphagnum* transfer to avoid flooding within the plots**

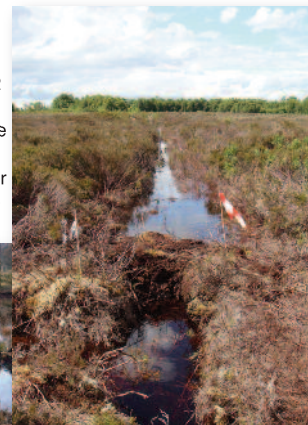
**The removal of peat to install dams on restoration sites provides the ideal opportunity to implement the *Sphagnum* transfer method**

A key finding was that over time successful *Sphagnum* colonisation can lead to a return of the characteristic active bog species to the area, a step towards restoring active bog habitat. Given the success of the 16th plot IPCC put forward that implementing the *Sphagnum* transfer method on borrow pits with adequate water table should be recommended as a best practice procedure where peat dams are being construction on raised bogs across Ireland.
